Hardware Performance Analysis of the Basic Narrow Microwave Landing System (MLS) at Washington National Airport (DCA) in the Service Test and Evaluation Program (STEP)

September 1985

DOT/FAA/CT-TN85/19

Technical Center
Atlantic City Airport, N.J. 08405

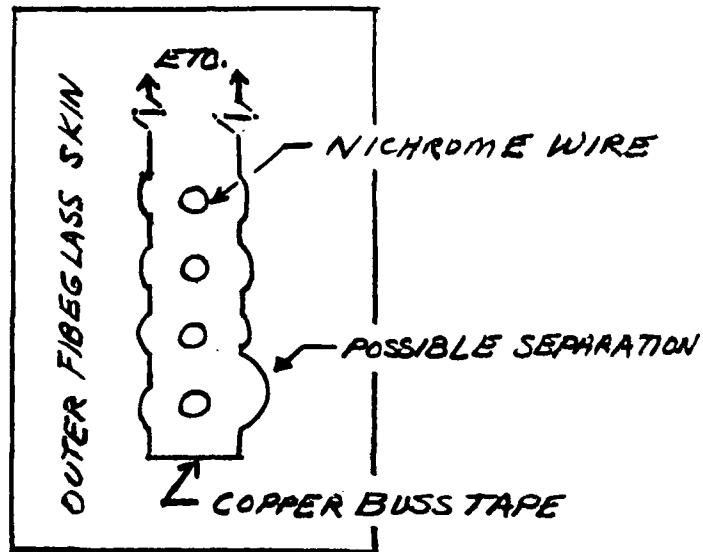
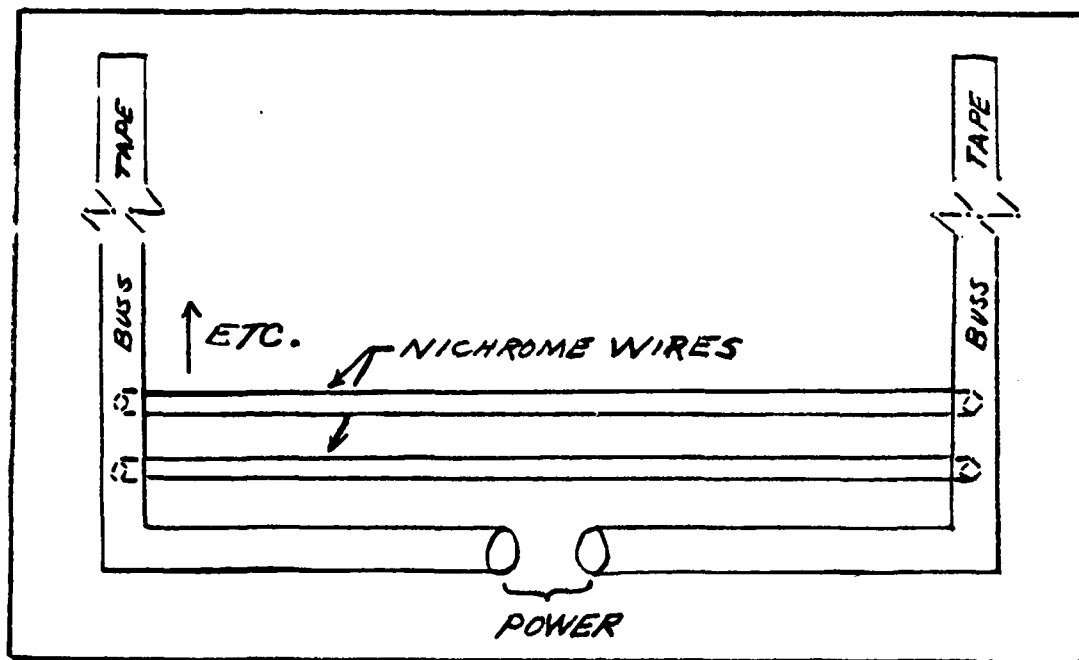
FIGURE A-1. BEAM ANTENNA RADOME'S OUTER FIBERGLASS SKIN

(2) On February 25, 1983, the site person investigated the burned radome area and determined that the two copper buss tape layers holding the nichrome heating wires in the damaged radome area were separated causing an arcing between the nichrome wire and copper buss tape.

(1) On March 3, 1983, the burned material of the beam antenna radome was removed, refilled with foam, and taped over.
